# Green Roof Management Plan

## Hillside Auditorium Green Roof

Office for Sustainability  
Jan Partain

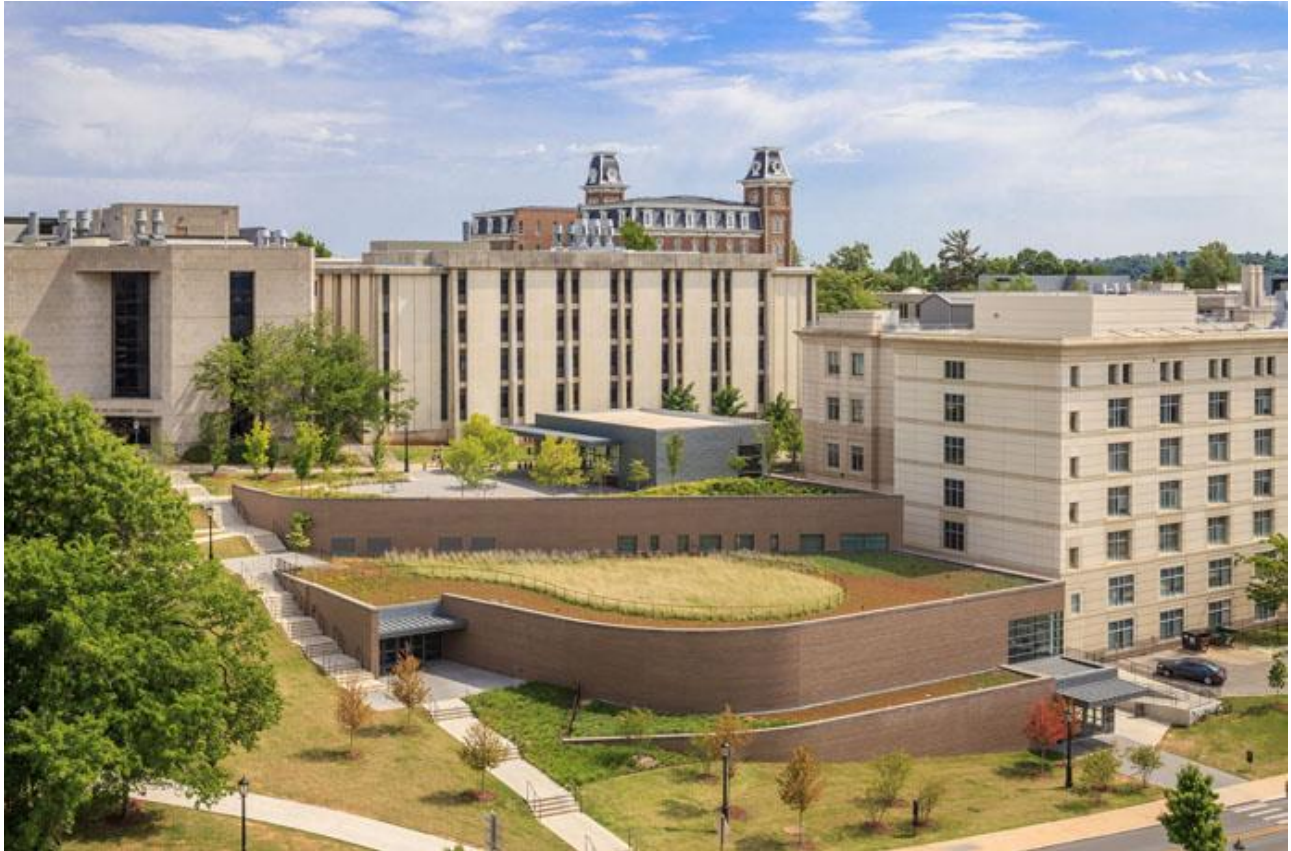
*Figure 1. Hillside Auditorium green roof shortly after installation.*

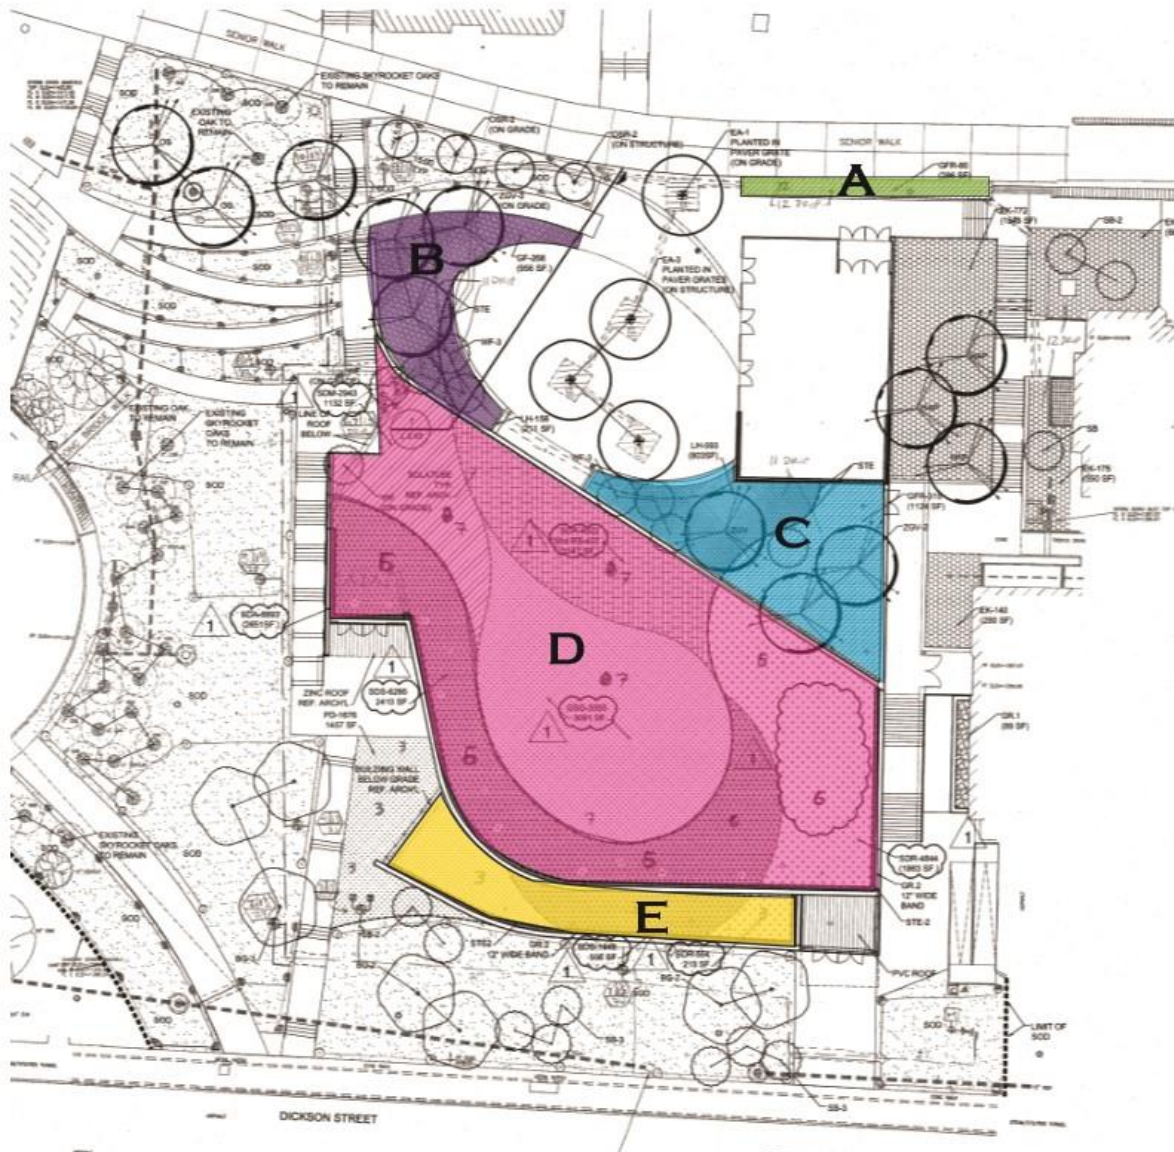
## HILLSIDE AUDITORIUM GREEN ROOF DIAGRAM

This proposal includes two segments. The first segment is an assessment of the current status of the installation. The second segment includes recommendations to recover both the ecological and aesthetic aspects of the original installation. These are presented for each section highlighted on Figure 2.

Figure 2. Diagram of the sections within the Hillside Auditorium green roof.

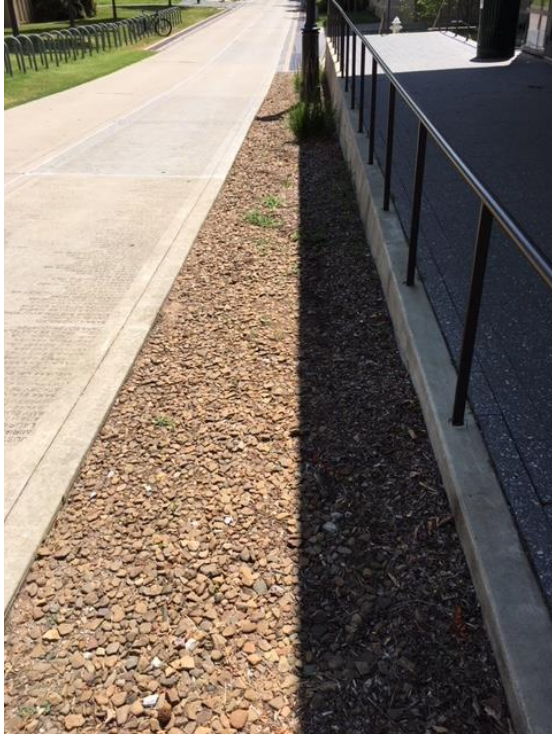
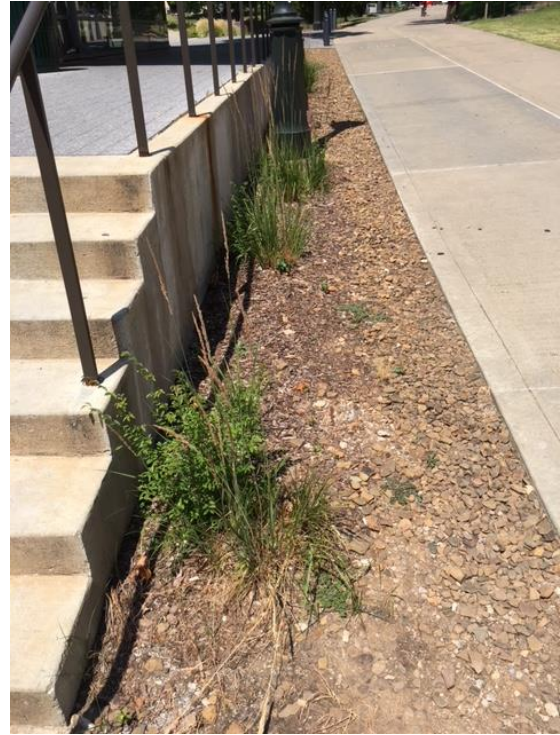
#### **Section A**

**Section A (green):** There are two or three plants left of the original *Calamagrostis x acutiflora* (Feather Reed Grass.) Sporadic weeds & grass permeate the decorative rock that covers the rest of the bed. This area seems to have experienced some drainage issues previously. See Appendix I Section A.

1. Keep the current plantings of *Calamagrostis x acutiflora* (Feather Reed Grass) and plant additional mature plants to fill in the area.
2. Correct the drainage issues and mulch well. Do not irrigate or mow.

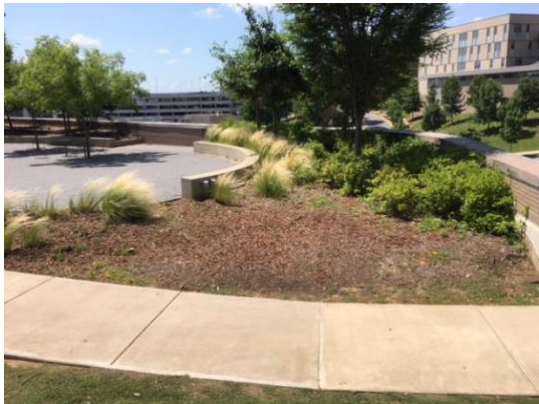
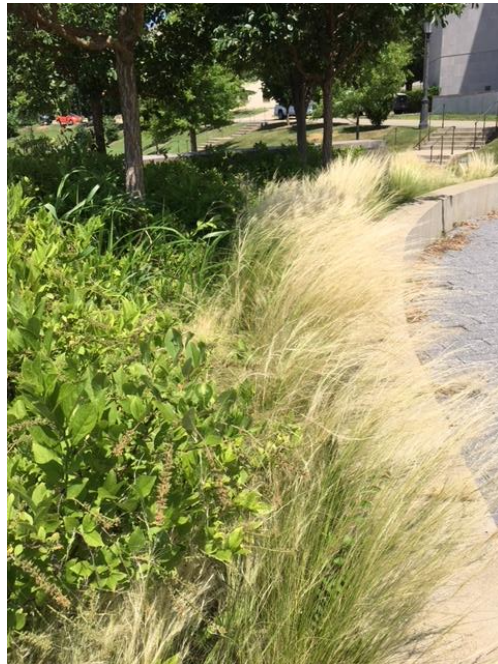
#### **Section B**

**Section B (purple):** Aside from the loss of the lavender hidcote and three elm trees, the remaining *Pennisetum alopecuroides* (Fountain Grass) appears to be thriving as does the *Itea* (Virginia Sweetspire) and the *Chionanthus virginicus* (White Fringe tree.) It was pointed out by Todd Furgason on our tour of the area in October that some significant settling has occurred in this section as well. See Appendix I Section B.

1. Keep the current plantings of *Pennisetum alopecuroides* (Fountain Grass) and plant additional mature plants to fill in the area where the elm trees were removed.
2. Mulch well and try to restrict irrigation to the remaining trees and *Itea* (Virginia Sweetspire).
3. Correct settling issues if appropriate.
4. Keep weeds in check and replace any dead grasses with like species as soon as possible for both sections A and B.

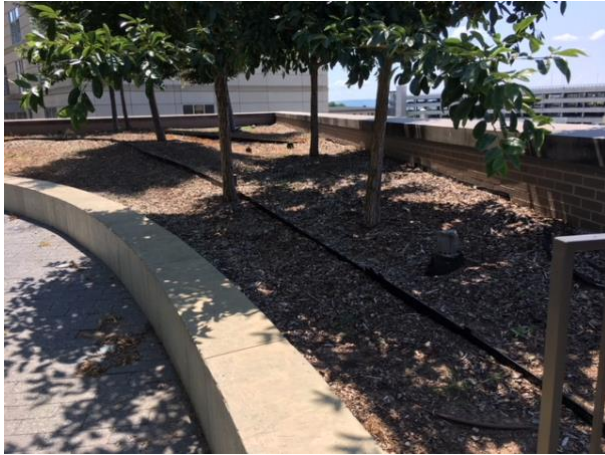
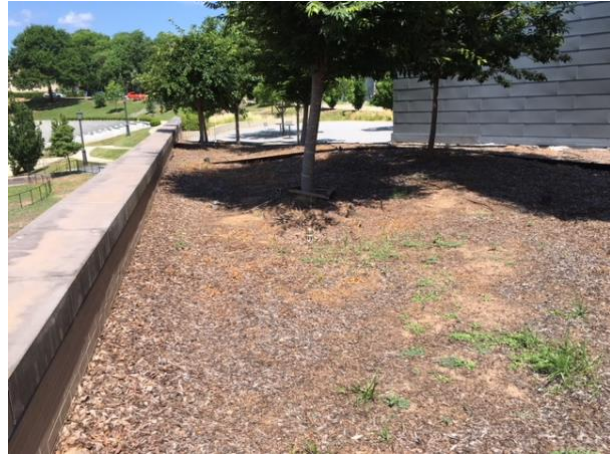
## Section C

**Section C (blue):** The only remaining vegetation in this section is the *Chionanthus virginicus* (White Fringe trees) and the *Zelkova serrata* (Zelkova Green Vase trees.) What did not survive were the ground covers of lavender hidcote and *Calamagrostis x acutiflora* (Feather Reed Grass), leaving bare ground. See Appendix I Section C.

1. Plant and mulch the area with a good shade tolerant native ground cover.
2. Maintain mulch depth to keep weeds in check and replant any bare/dead spots as needed.

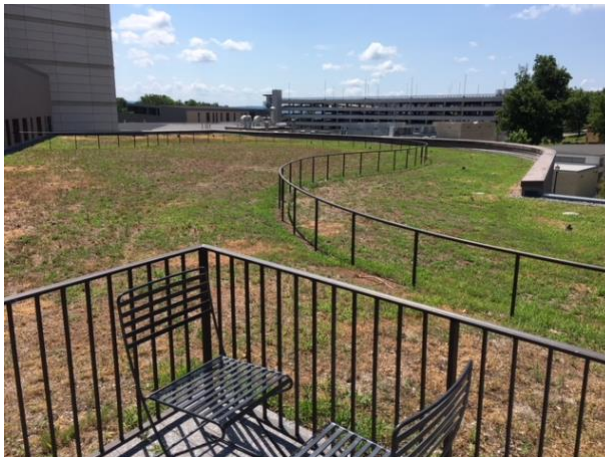
## Section D

**Section D (pink):** The area has been completely taken over by weeds. Currently, the roof is mowed periodically (monthly or every 2 weeks) in season and the edges and railing are sprayed with an herbicide, most likely glyphosate (Round-Up.) The weeds are numerous and invasive, a partial listing includes:

There is no sign of the *Butela curpendula* (Sideoats Grama grass) and only a few sporadic spots of the sedum species originally planted are present. Some evidence of the grasses remains in spots but has been mowed to ground level. There are a few *Perovskia atriplicifolia* (Russian Sage) plants remaining and thriving near the gate along with two *Chionanthus virginicus* (White Fringe trees.) See Appendix I Section D.

Mowed in Mid-June

1. Weed Eradication
  - a. Consult with UARK Weed Science on types of weeds and recommended cultural, mechanical and chemical management practices to reduce current weed problem without high herbicide residual activity.
  - b. This vegetation will then need to be completely removed from the area and planting media added.
2. It is recommended to leave the White Fringe trees and the Russian Sage that is thriving and to seed/plant the remaining area with similar prairie grasses that are thriving in other sections of the green roof. Recommended is *Pennisetum alopecuroides* (Fountain Grass) or *Sporobolus heterolepis* (Prairie Dropseed.)
3. Keep weeds in check and replace any dead grasses with same or like species.
4. Do not irrigate or mow this area on an ongoing basis. Mowing will be seasonal only, 1-3 times per year.

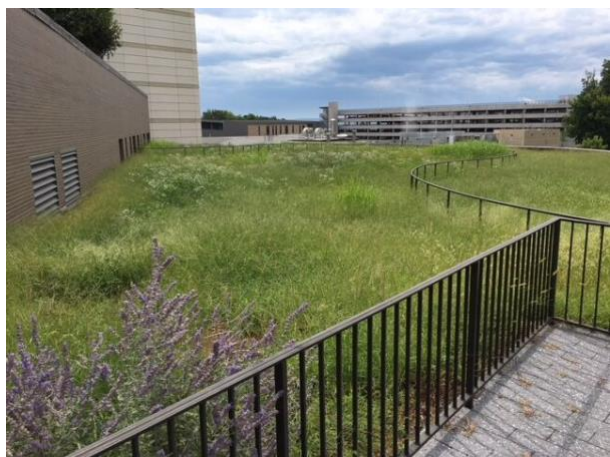
Not Mowed-late July

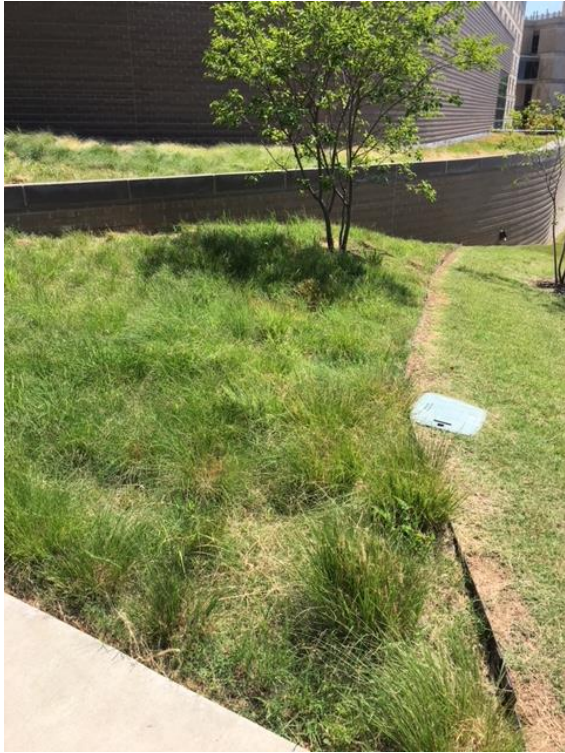
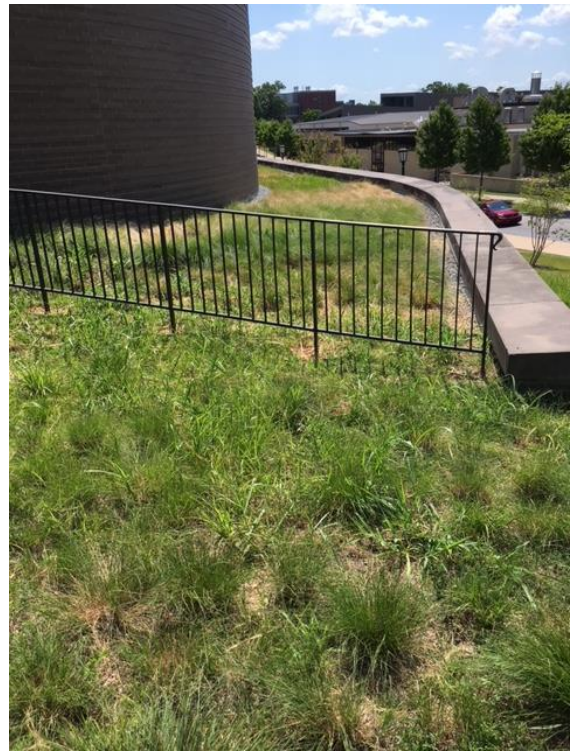
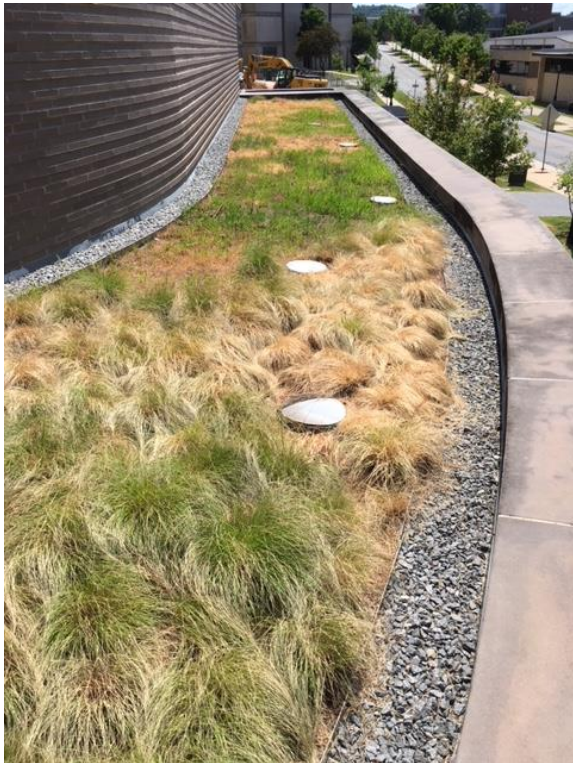
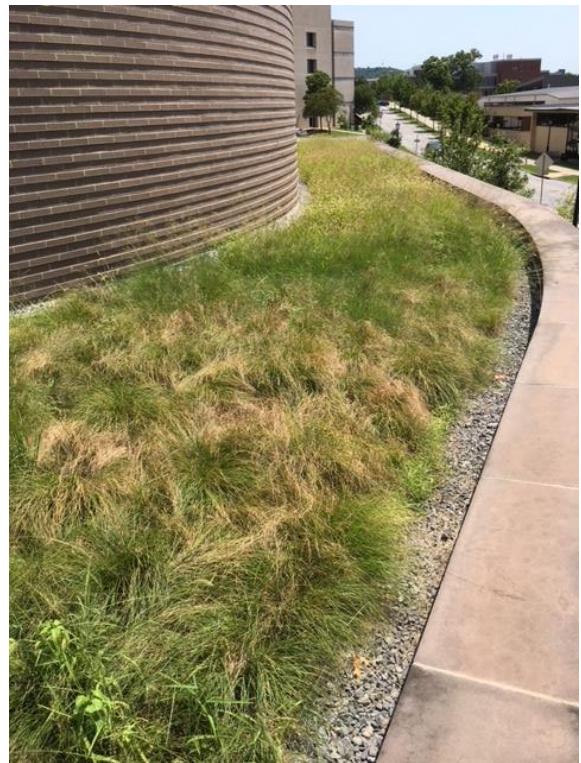
## Section E

**Section E (yellow):** Original plantings included some of the same species planted on the middle roof area. In this section the *Butela curpendula* (Sideoats Grama grass) seems to be thriving where it has not been mowed. The area where the grama grass has been mowed has been invaded by the Bermuda grass. The sedum species are splotchy at best being overtaken by weeds and grass. (**NOTE:** *Sporobolus heterolepis* (Prairie Dropseed) may have been substituted for Sideoats Grama from the original plans.) See Appendix I Section E.

1. Plant the entire area with the grasses currently thriving near the gate in this section to replace the lost sedums from the initial planting.
2. It is recommended that the lower section of this area be installed with Bermuda grass sod leaving only the upper area with the prairie grasses extending from the wall to the sidewalk and remove the fencing.
3. Supplement planting media &/or mulch to hide irrigation lines.
4. Do not irrigate or mow this area on an ongoing basis. Mowing will be seasonal only, 1-3 times per year.
