A Step in the Right Direction: Streambank Restoration Efforts at the Botanical Garden of the Ozarks

Department of Crop, Soil and Environmental Science, University of Arkansas, Fayetteville, Arkansas

Project Overview

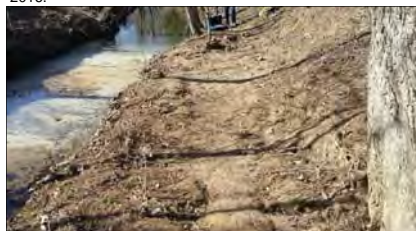
Figure 1. Hilton Creek streambank pre-restoration, 7 Feb., 2016.

The Hilton Creek streambank pre-restoration site was bare with exposed soil, lacking vegetation (Figure 1). Post-restoration holds a diversity of native vegetation covering the soil (Figure 2). Soil test kits indicated the Hilton Creek streambank pre-restoration soil contained 81.82 and 84.07 (kg/ha) of nitrate and phosphorus respectively, and had a pH of 6.9 (Figure 1). Soil test values confirmed the site was suitable for the desired planting design of native trees, shrubs, herbaceous perennials, ferns, and grasses (Figure 3). Cataloged plant species equated to a pre-restoration Shannon-Wiener Index of diversity value of 2.13, while the post-restoration Shannon-Wiener Index of diversity equaled 2.91 (Figure 4). Results for water quality (Figures 5-8) are displayed with green bars representing 35 m upstream from the middle of the restoration site, blue bars representing the middle of the restoration site, and red bars being 35 m downstream from the middle of the restoration site. Pre-restoration QBR index value was calculated as 40 out of 100 and post-restoration QBR index value was calculated as 70 out of 100. Results show quantitative and visual differences post-restoration through increased plant diversity.

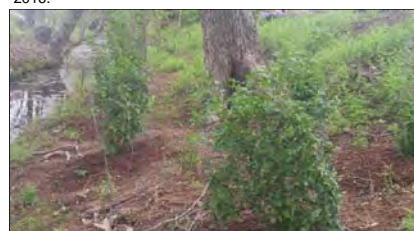
Figure 2. Hilton Creek streambank post-restoration, 16 Mar., 2016.
